MARINE GAS TURBINE HOT CORROSION
DEPENDENCE ON INGESTED SALT LEVELS

Report No. FR-11544

R.H. Barkalow and F.S. Pettit
United Technologies Corporation
Pratt & Whitney Aircraft Group
Government Products Division
West Palm Beach, FL 33402

16 April 1979

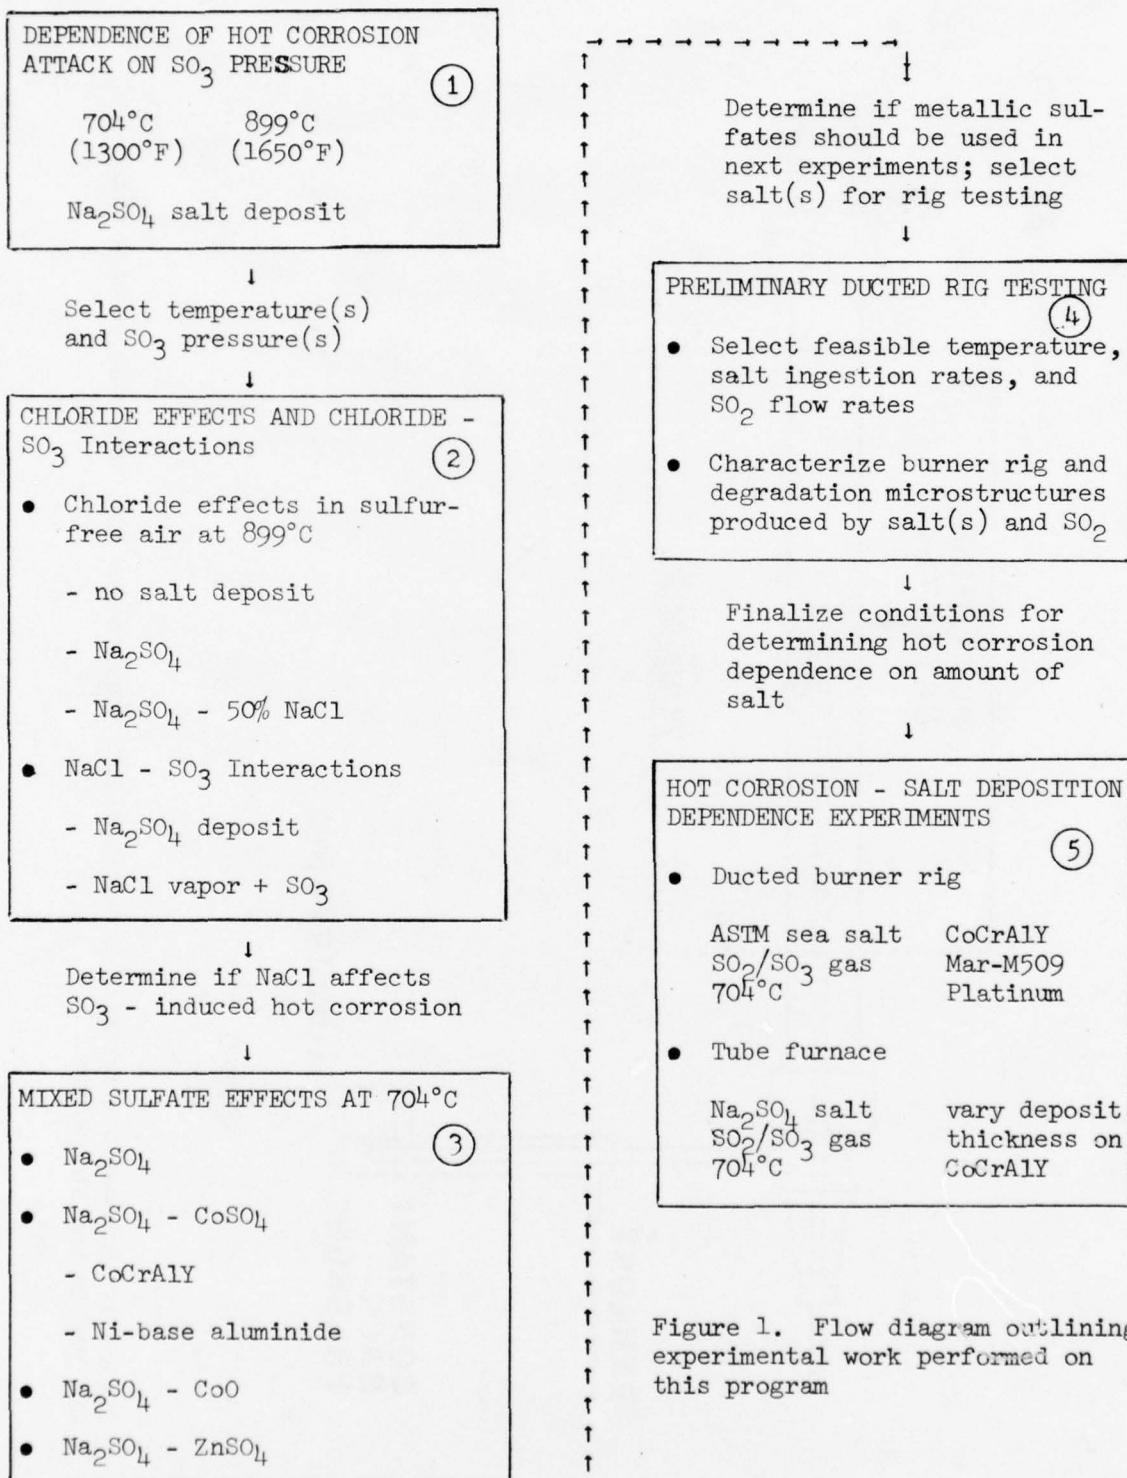
Figure 1. Flow diagram outlining experimental work performed on this program

Conclusions and inferences from the service evaluation and laboratory test results summarized in the preceeding paragraphs were the basis of formulating the test plan for this program as outlined in Figure 1. The plan includes tube furnace experiments to provide basic data on the effects of important hot corrosion variables and burner rig testing to determine severity of hot corrosion versus ingested salt level. Implicit in both types of experiments is the assumption that the partial pressure of SO_3 in the gaseous environment is a critical parameter. Hence, except for baseline furnace experiments to compare sulfur-containing versus sulfur-free air, all testing is done at controlled values of SO_3 pressure.

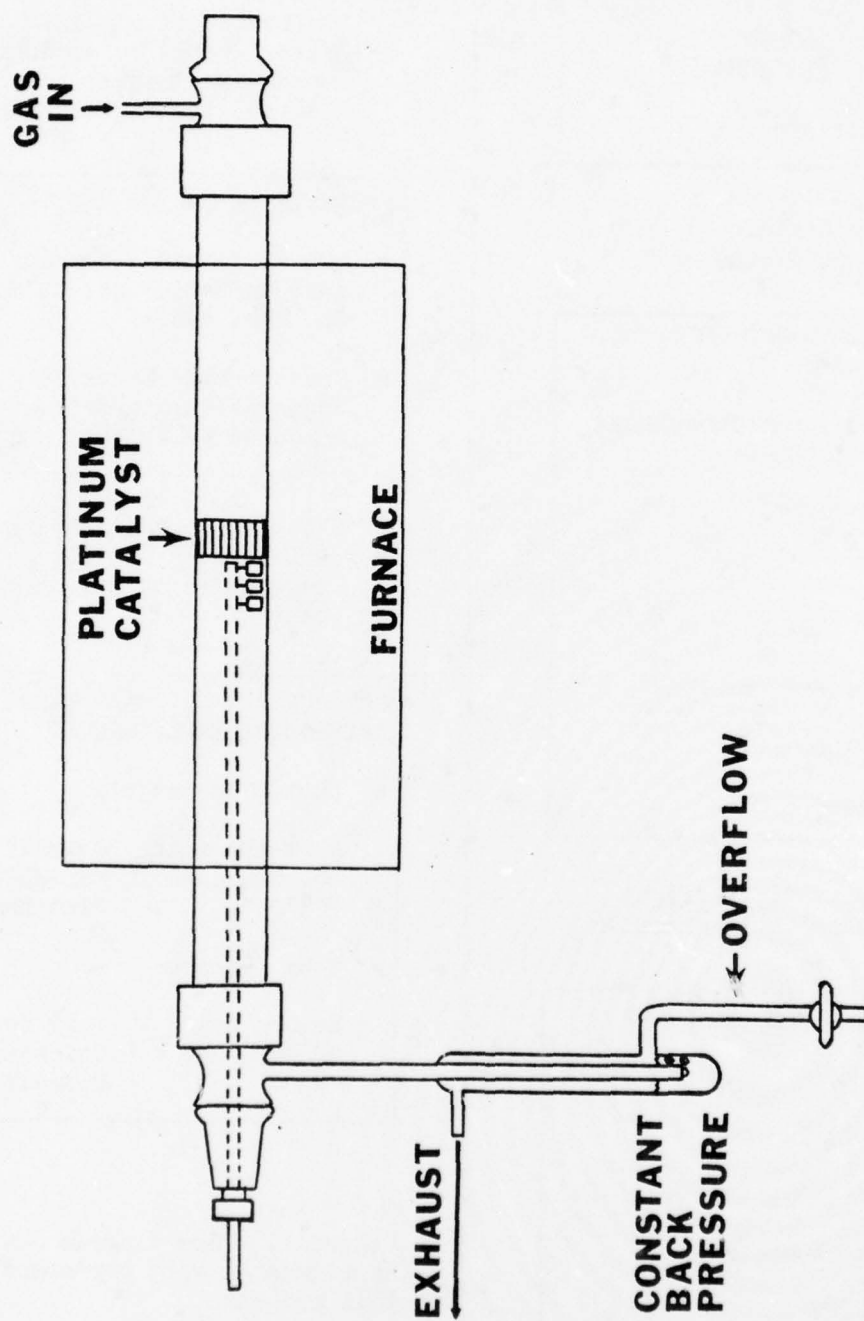
Figure 2. Schematic diagram of horizontal tube furnace for hot corrosion testing with SO_3 gas in the atmosphere.

All tests were performed in the horizontal tube furnace illustrated in Figure 2. The input gas was mixed from bottled SO_2 and O_2 with flowmeters capable of providing ratios as low as 0.0001 volume fraction SO_2 ; total flowrate was 11.5 liters/hour. A catalyst of sputtered platinum on DuPont Torvex® honeycomb alumina was maintained at the same temperature as the specimens, which were suspended on platinum wires from a ceramic tube. The specimens were coated with 1 mg/cm^2 of Na_2SO_4 , exposed for 20 hours, water washed, and recoated with fresh salt for continued testing. Total exposure time was 100 hours unless sooner terminated because of severe attack.

The air experiments were performed in a vertical tube furnace; those involving NaCl vapor were run in the horizontal furnace of Figure 2 by inserting a salt-filled boat upstream of the specimens. Material behavior

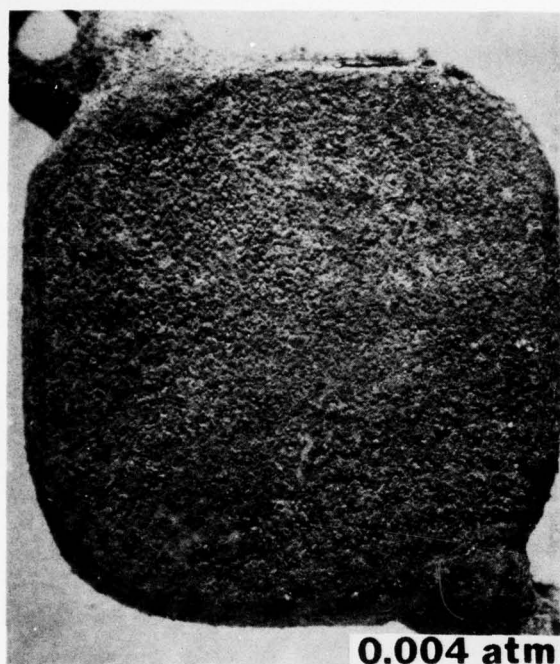
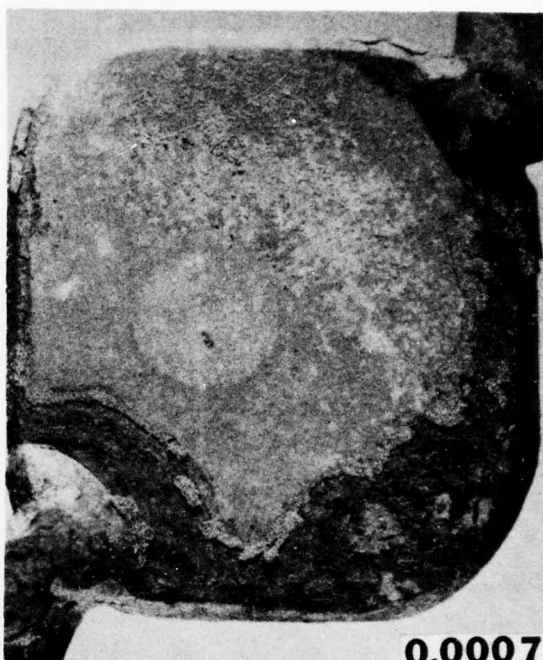
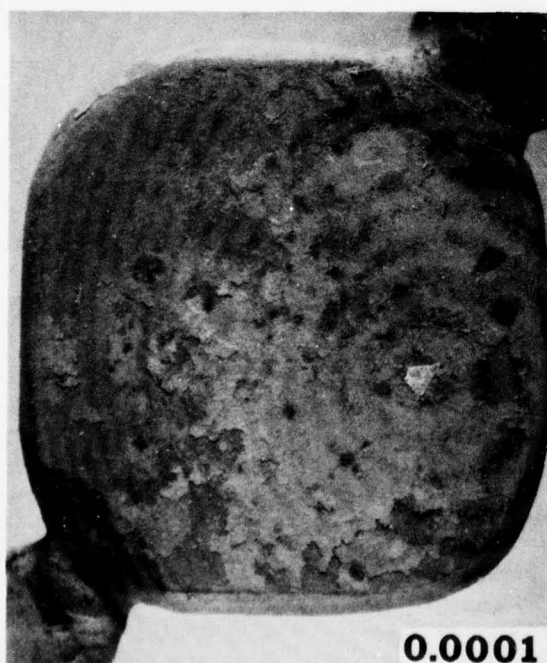
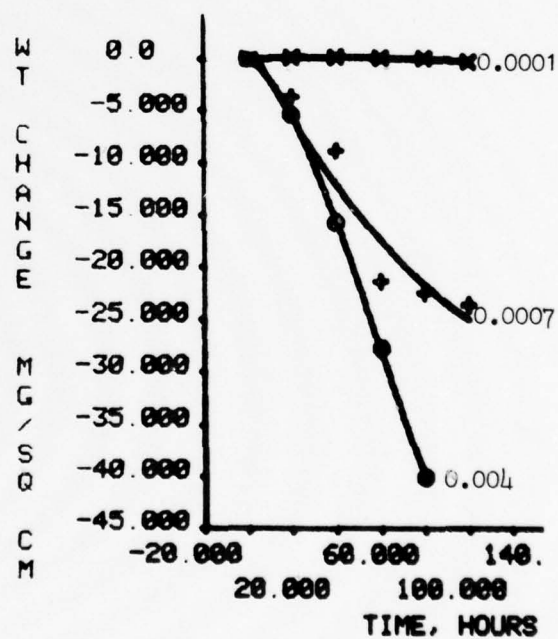
Figure 3. Effect of SO₃ pressure on 704C sulfate-induced hot corrosion of CoCrAlY-coated (PWA 68; Co - 15 to 24 Cr - 11.5 to 13.5 Al - 0.2 to 0.7 Y) IN 792, as shown by surface condition after 20 hours and weight change data for 100-hour cyclic exposure.

Surface photographs and weight change data showing severity of attack versus SO_3 pressure are presented in Figures 3 - 8. Except for an unusually large weight loss of one of the specimens (uncoated IN 792) at the intermediate value of p_{SO_3} , all observations and $\Delta M/A$ data indicate strong and consistent dependence of severity of attack on SO_3 pressure.

The surface photographs in Figures 3 - 7 are those taken of each specimen at the initial examination after 20 hours exposure, where the difference in surface condition as a function of SO_3 pressure was most evident. The effect of SO_3 pressure on severity of attack - especially at 0.004 versus 0.0007 atm - was not well illustrated by black and white surface photographs after longer exposure times, although the difference in degradation of the coated specimens at 0.0007 versus 0.0001 atm was apparent (Figure 8).

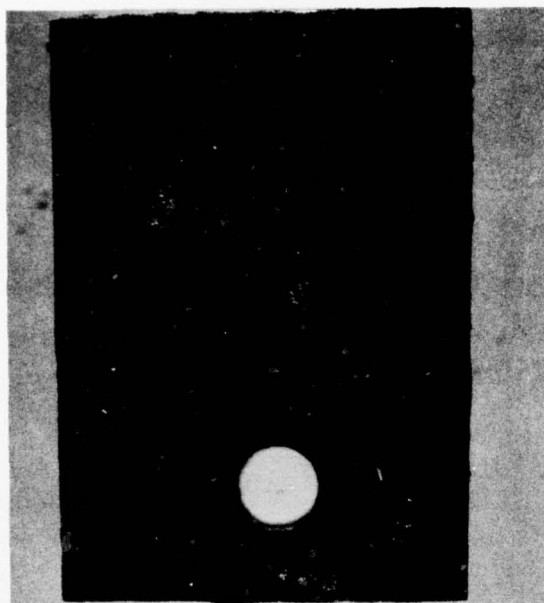
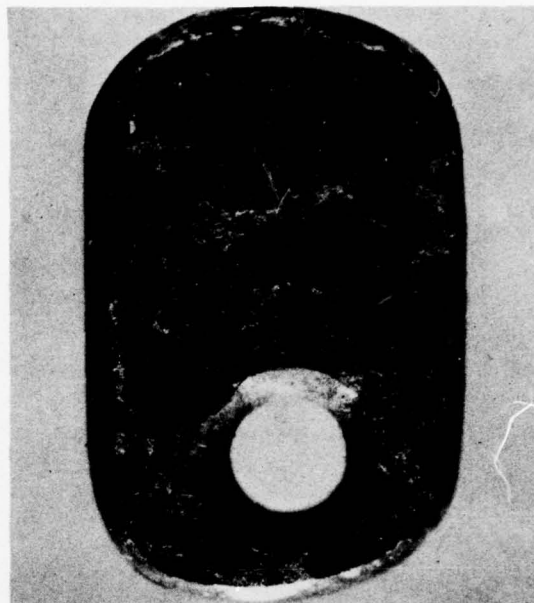
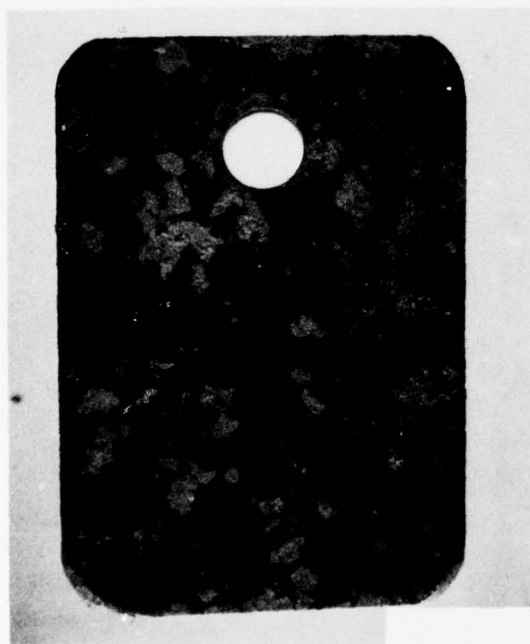
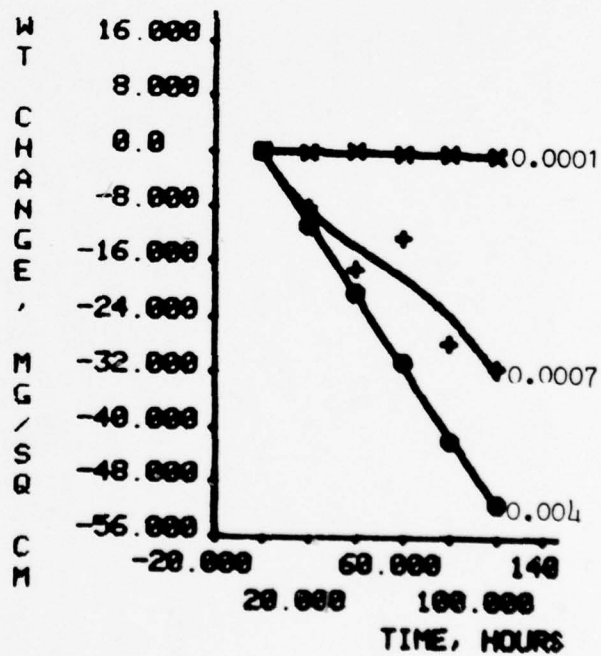
Figure 4. Effect of SO_2 pressure on 704C sulfate-induced hot corrosion of uncoated Mar-M509 (Co-23.4Cr-10.0Ni-0.2Ti-7.0W-3.5Ta-0.5Zr-0.6C), as shown by surface condition after 20 hours and weight change data for 100-hour cyclic exposure.

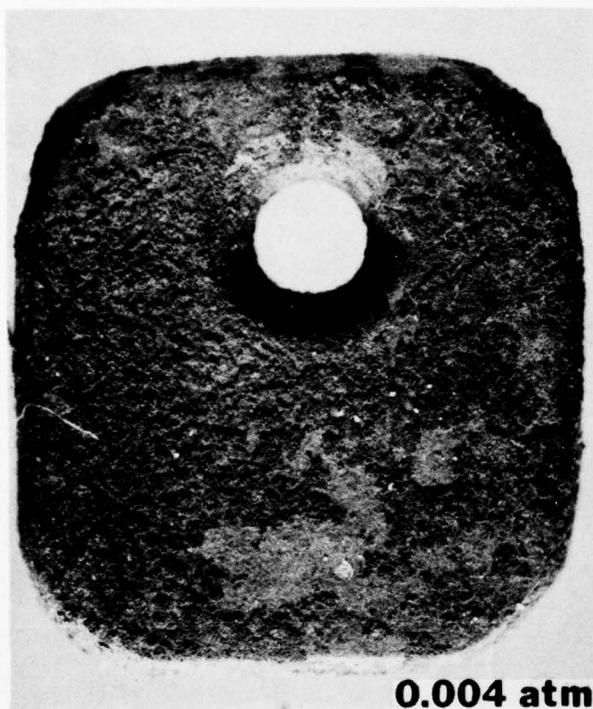
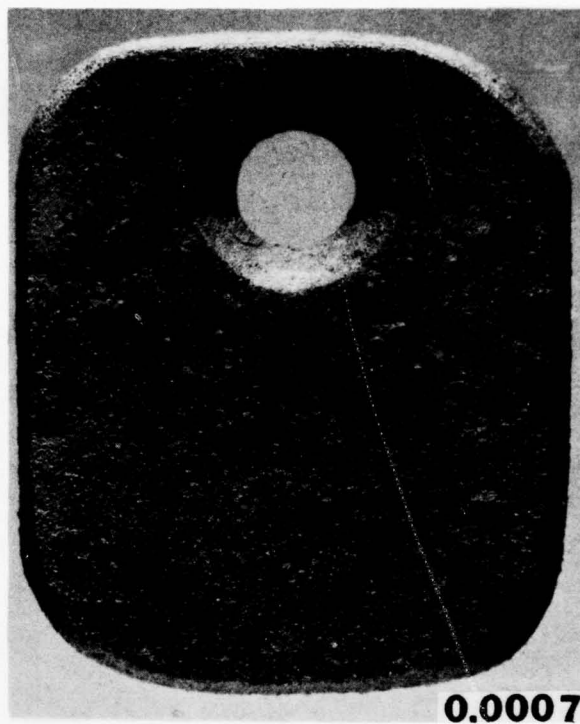
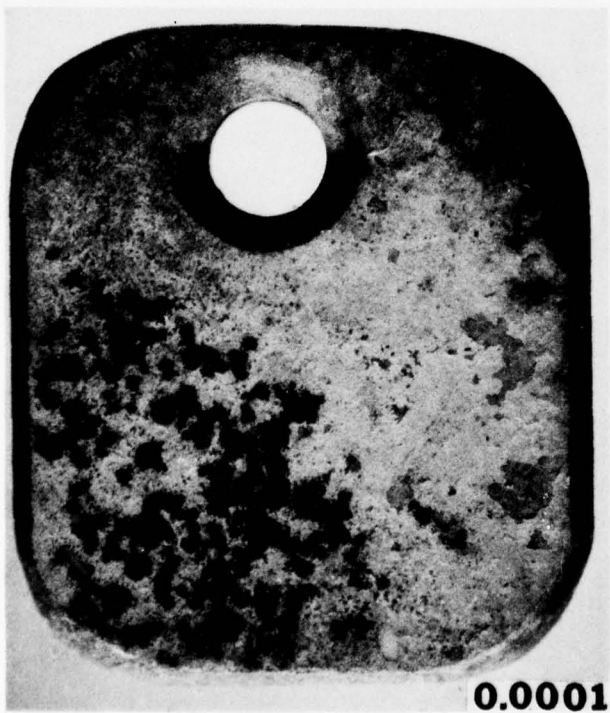
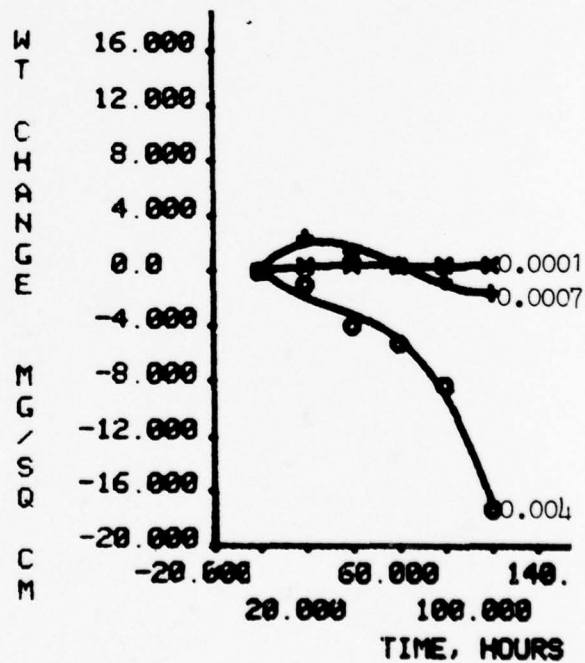
Figure 5. Effect of SO_2 pressure on 704C sulfate-induced hot corrosion of aluminized (PWA 28) Mar-M509, as shown by surface condition after 20 hours and weight change data for 100-hour cyclic exposure.

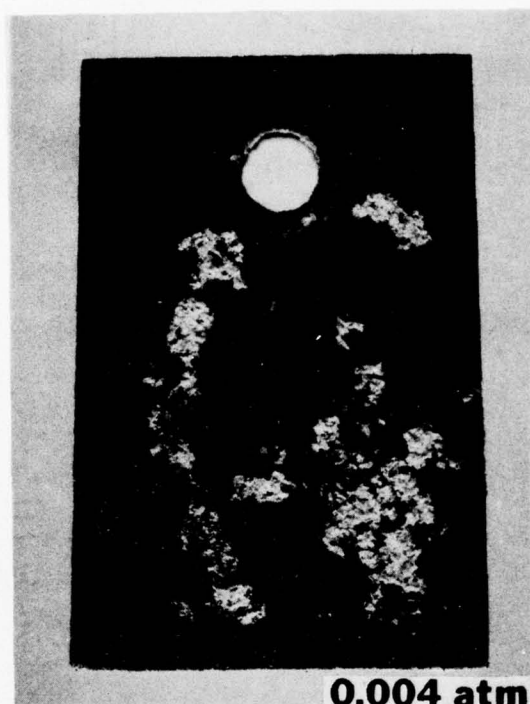
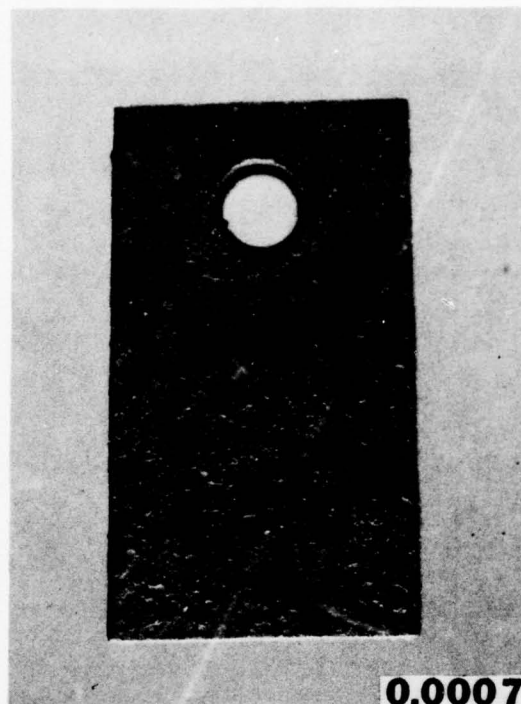
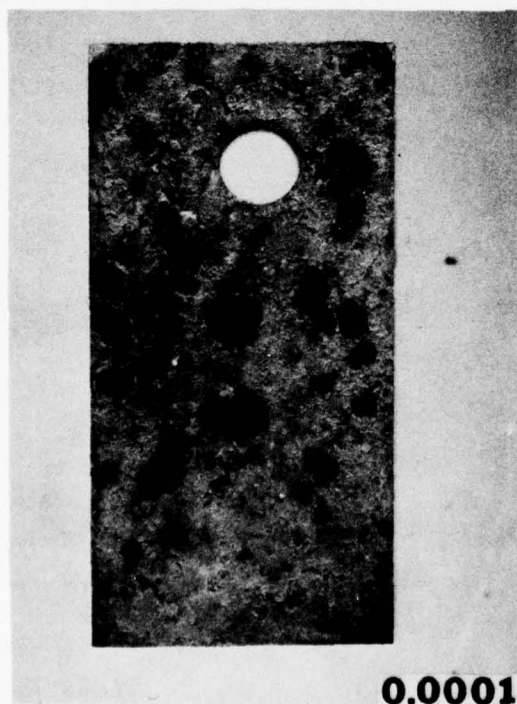
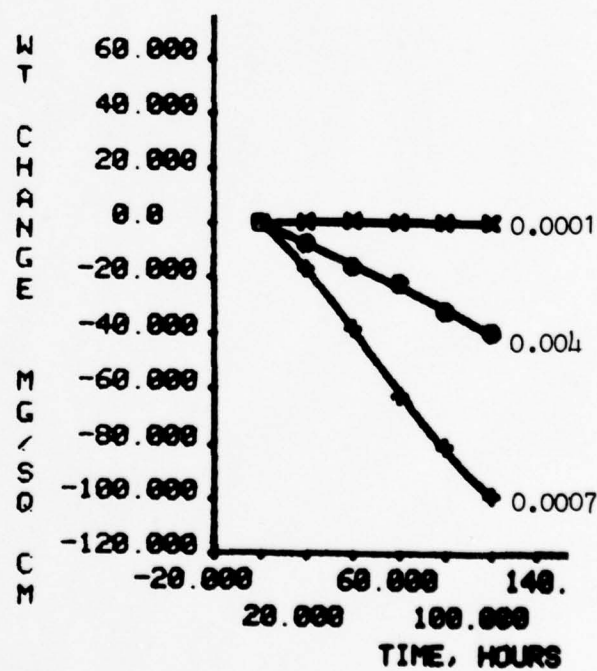
Figure 6. Effect of SO_2 pressure on 704C sulfate-induced hot corrosion of uncoated IN 792 (Ni-12.0Cr-9.0Co-4.5Ti-3.1Al-1.9Mo-3.8W-3.9Ta-0.12C-0.1Zr-0.02B), as shown by surface condition after 20 hours and weight change data for 100-hour cyclic exposure.

At $p_{\text{SO}_3} = 0.0007$ atm, uncoated IN 792 suffered large weight changes at both 704 and 899°C (Figure 30a). Although the weight loss at 704°C may have been anomalously large (Figure 6), it is clear from corresponding

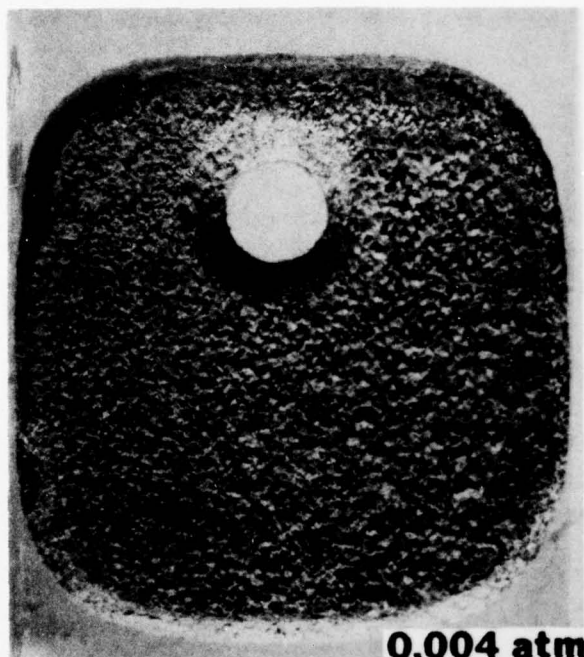
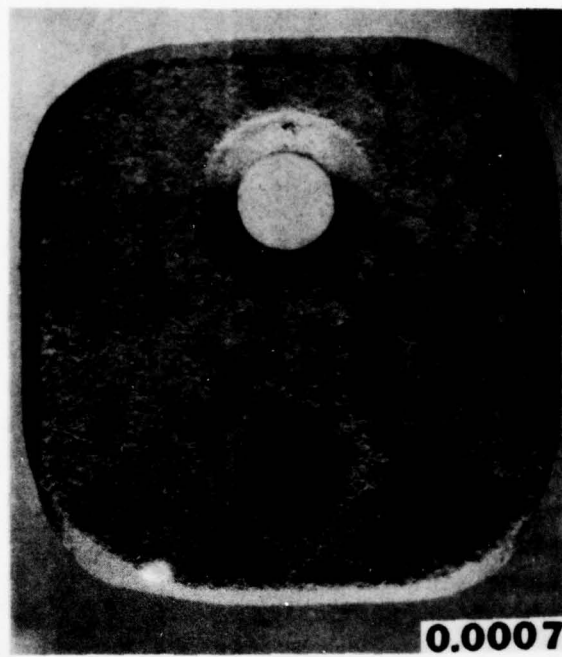
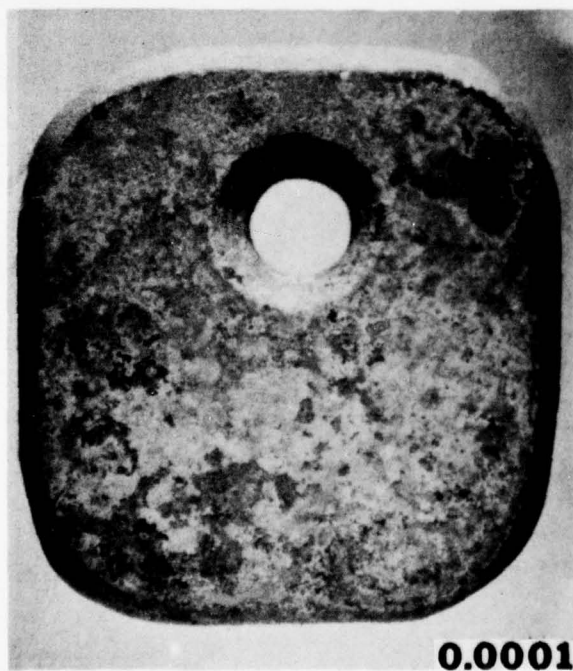
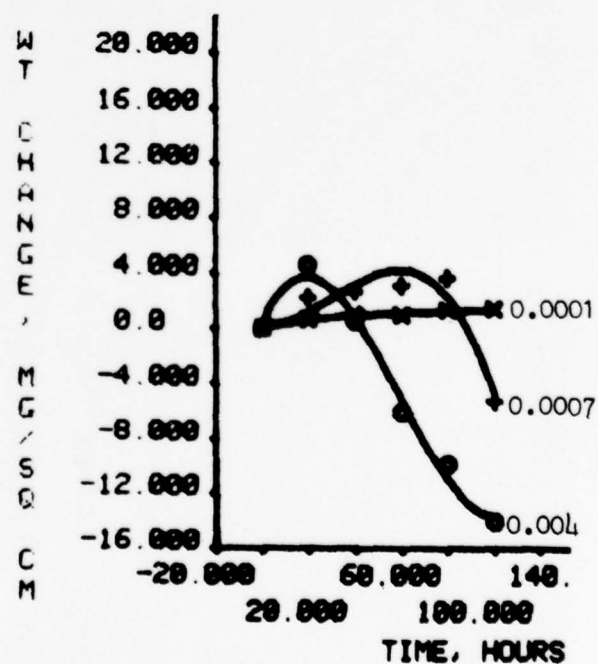
Figure 7. Effect of SO_3 pressure on 704C sulfate-induced hot corrosion of aluminized (PWA 273) IN 792, as shown by surface condition after 20 hours and weight change data for 100-hour cyclic exposure.

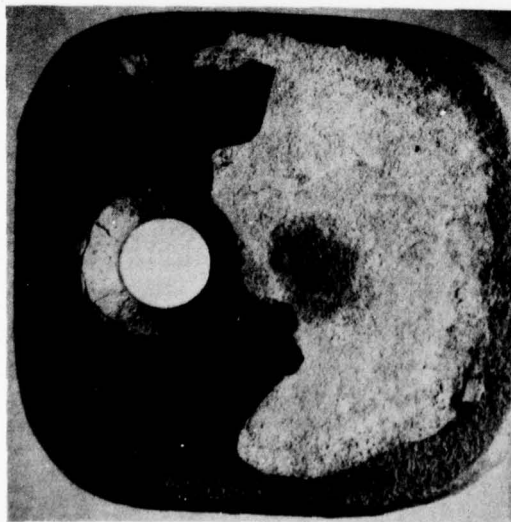
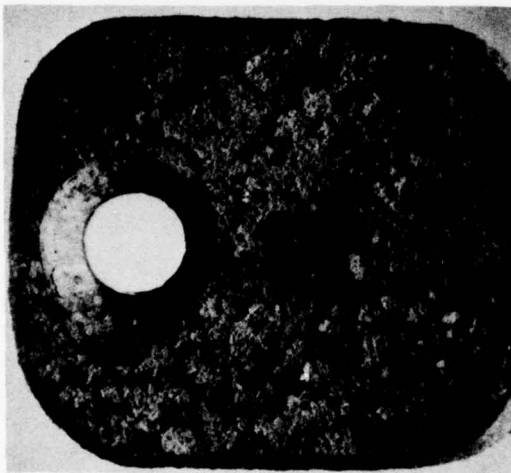
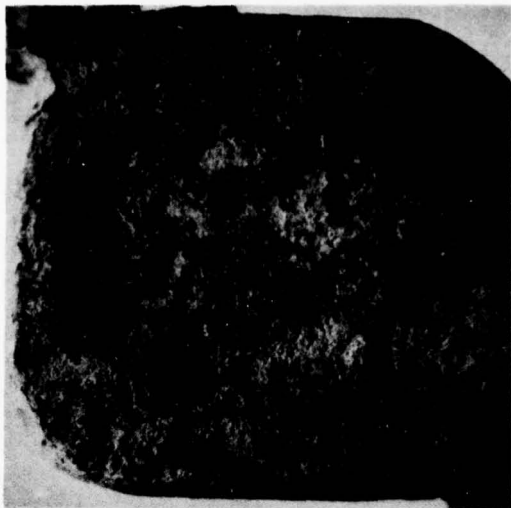
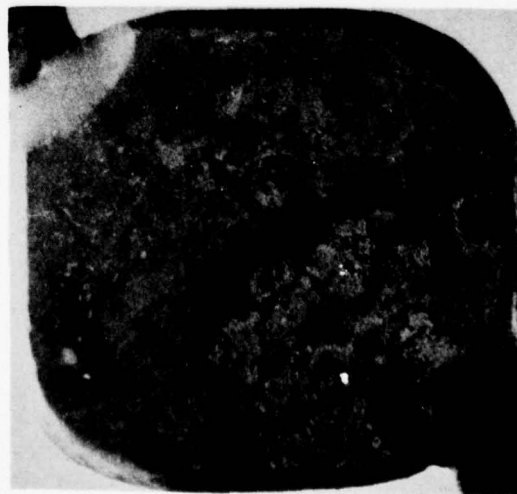
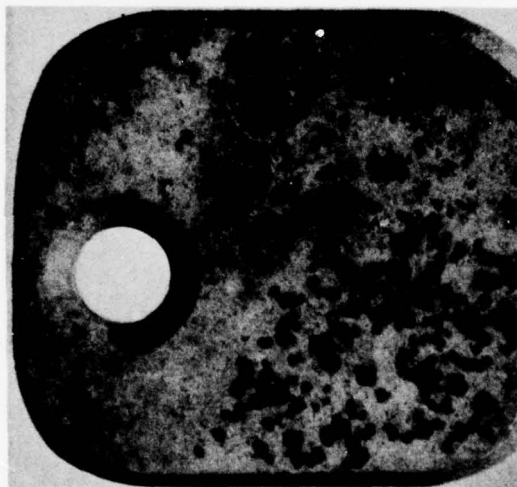
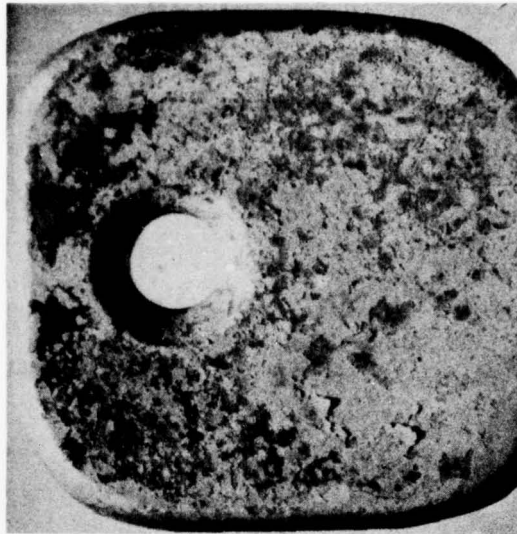
Figure 8. Effect of SO_2 pressure on 704C sulfate-induced hot corrosion of CoCrAlY and aluminide coatings (PWA 68 on IN 792, PWA 28 on Mar-M509, and PWA 273 on IN 792), as shown by surface condition after 100-hour cyclic exposure.

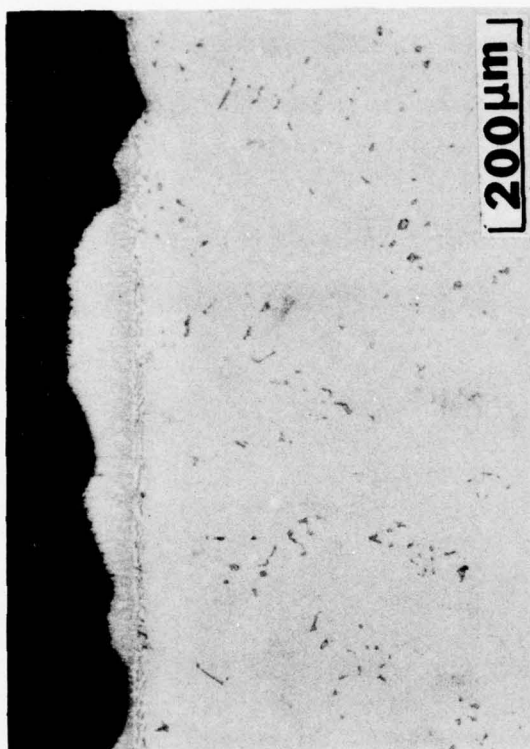
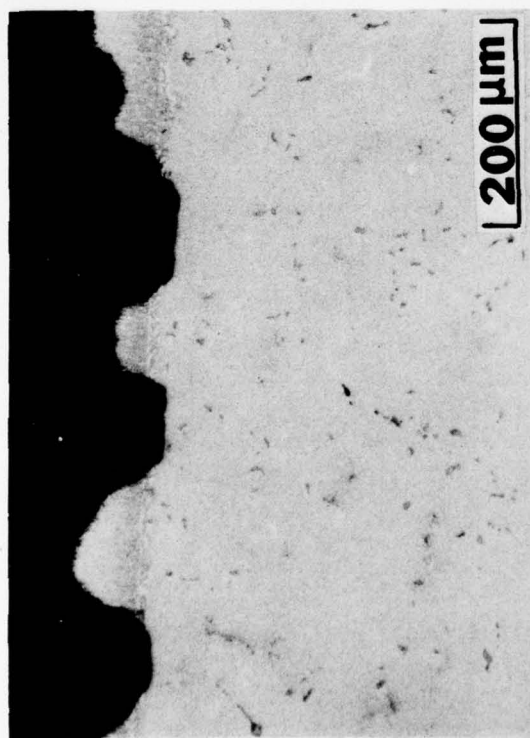
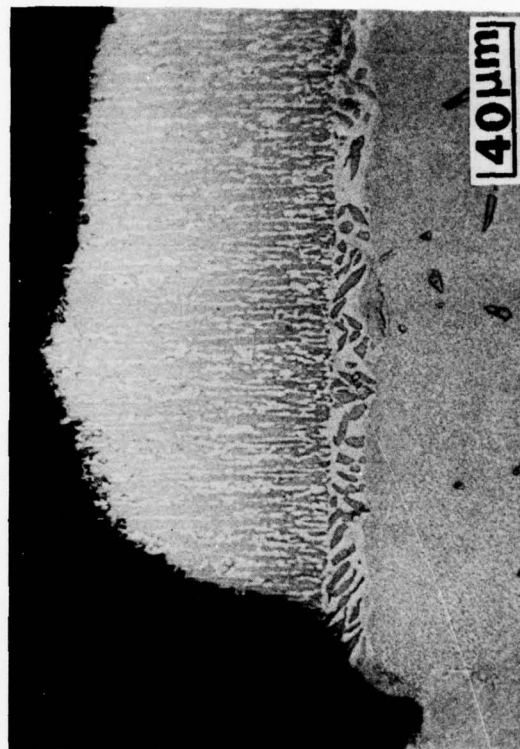
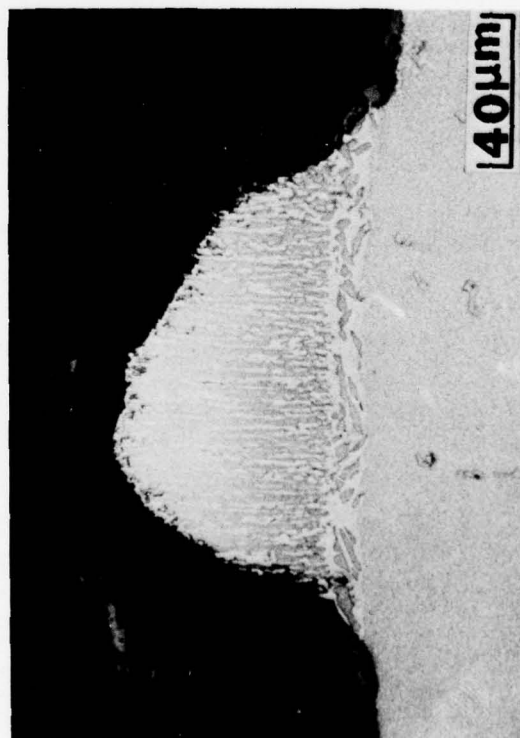
Figure 9. Typical depth of attack and nodular morphology of corrosion front produced by cyclic exposure of PWA 68 CoCrAlY for 100 hours at 704°C and $PSO_3 = 0.004$ atm. Specimen was lightly etched to emphasize coating thickness and microstructure.

Post-test metallography showed that the PWA 68 CoCrAlY coating tested at 0.004 atm SO_3 was penetrated or almost penetrated in numerous locations, with most areas showing general surface degradation as well as localized nodular attack (Figure 9). The uncoated alloys in the same test (Figures 10a, 10b) showed highly irregular surfaces reflecting the substantial material consumption and scale spallation inferred from visual inspection and the large weight losses; however, there was no indication of alloy depletion, sulfide precipitation, or internal oxidation in advance of the scale/metal interface. The PWA 28 aluminide coating on Mar-M509 was almost completely consumed; the heavy scale shown in Figure 10c was spalled off in most areas and substrate attack was observed. In contrast, the PWA 273 on the Ni-base IN 792 was heavily attacked but still protective (Figure 10d).

Less severe attack, especially of the Co-base coatings, at $p_{\text{SO}_3} = 0.0007$ atm is evident from comparison of Figures 11 and 12 versus Figures 9 and 10. The CoCrAlY and the Co-base aluminide both failed in the 100-hour test at 0.004 atm; at the lower SO_3 pressure, both were substantially corroded but still intact, at least over most of the area of the specimen.

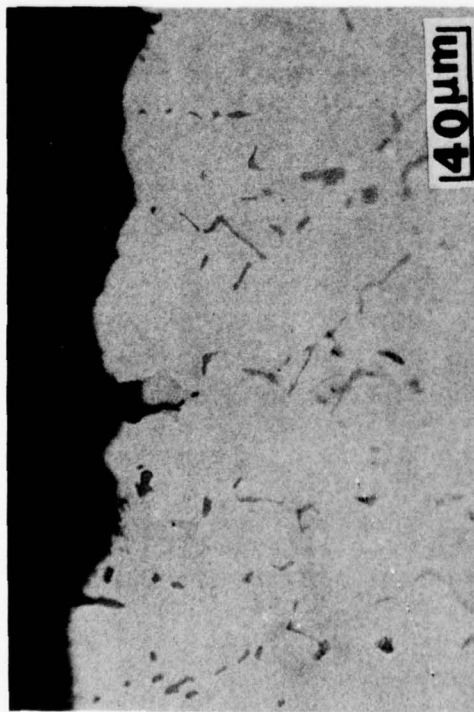
10a. Uncoated Mar-M509

Figure 10. Uncoated and aluminized alloys tested concurrently with the CoCrAlY coating of Fig. 9 (i.e. 100 hours at 704C, $PSO_3 = 0.004$ atm). Arrow in 10c shows innermost diffusion zone of the PWA 28 microstructure; the rest of the coating was completely oxidized and spalled off in most areas.

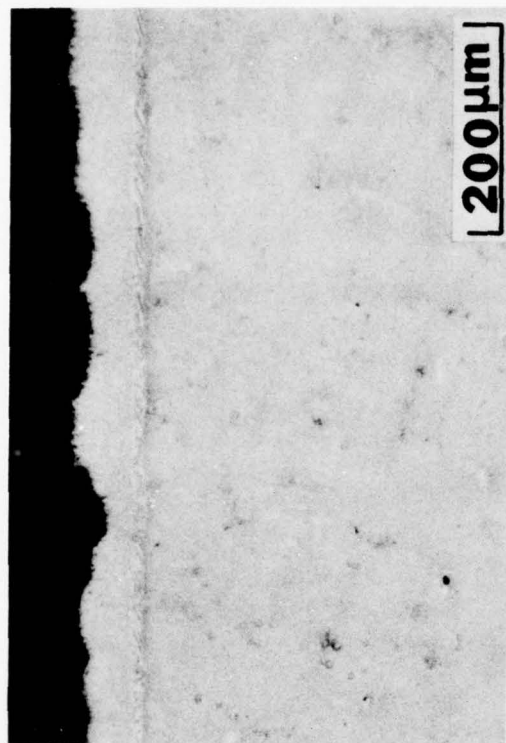
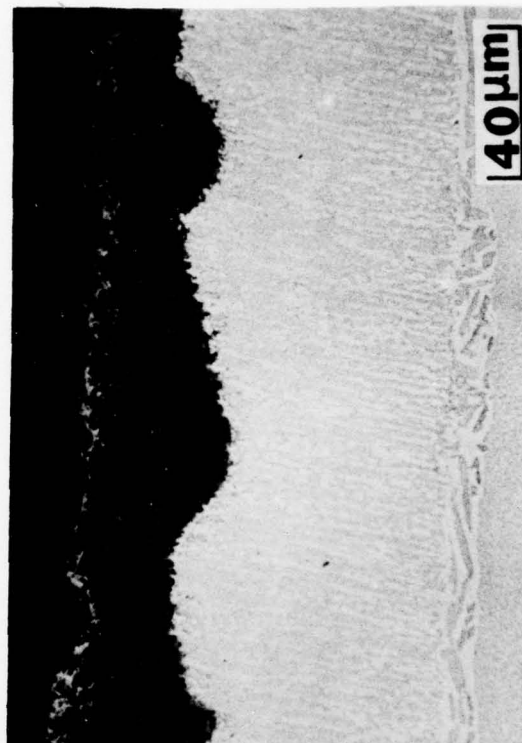
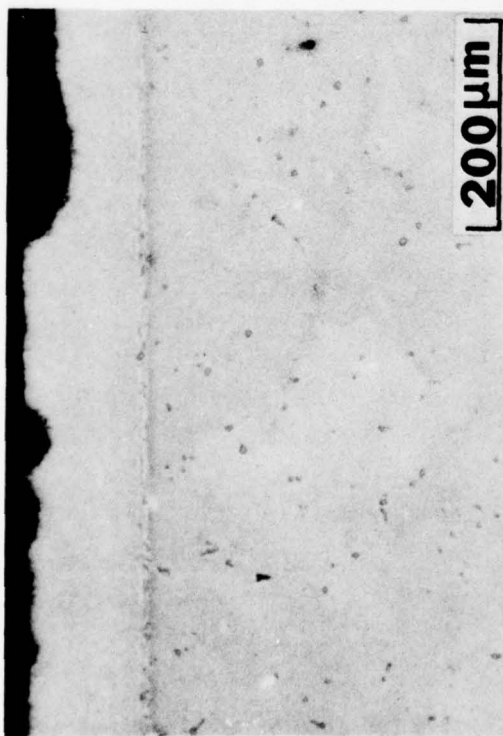
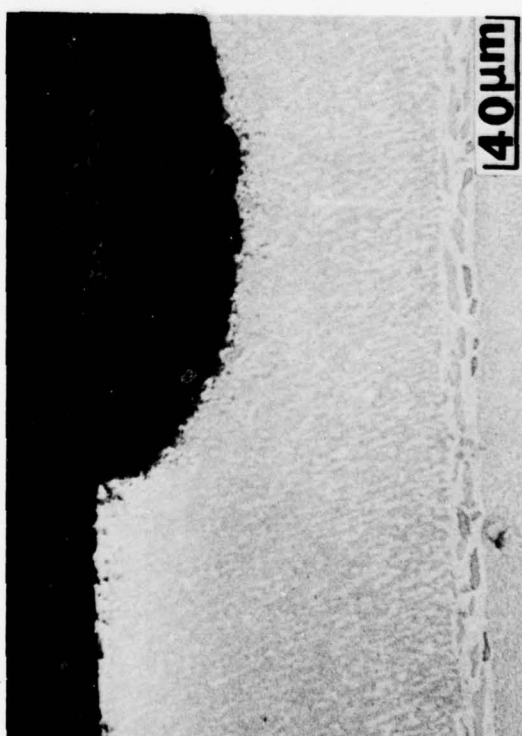
Figure 11. Typical depth of attack and nodular morphology of corrosion front produced by cyclic exposure of PWA 68 CoCrAlY for 100 hours at 704°C and $p_{SO_2} = 0.0007$ atm. Consumption of approximately half of the coating was observed in many areas, but the coating was apparently not penetrated.

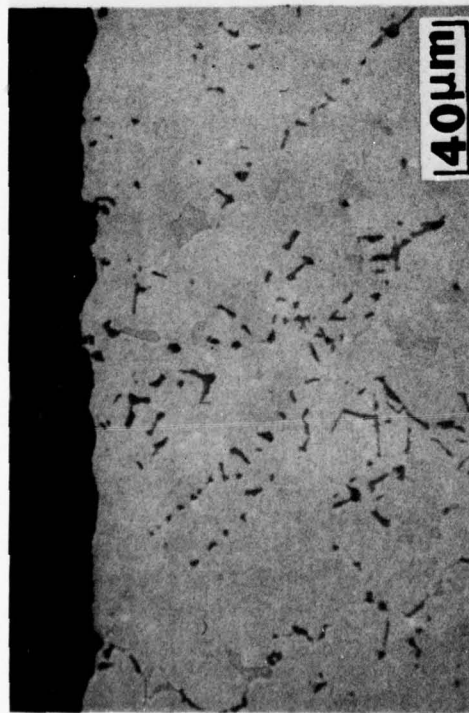
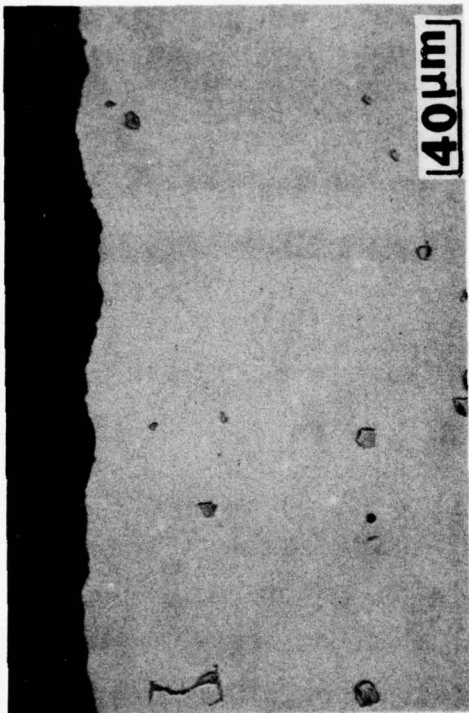
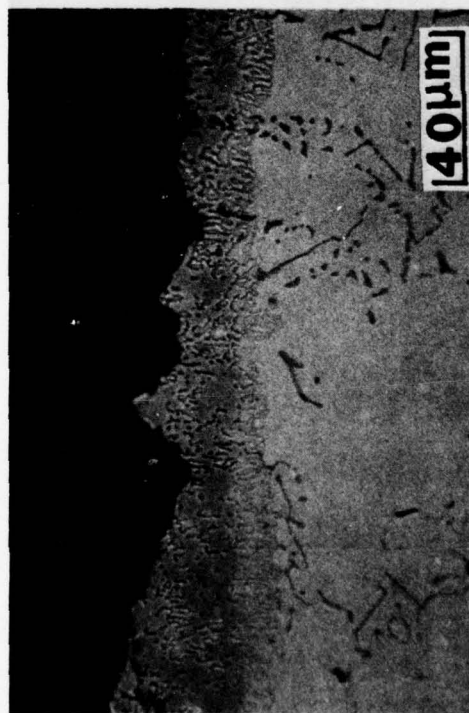
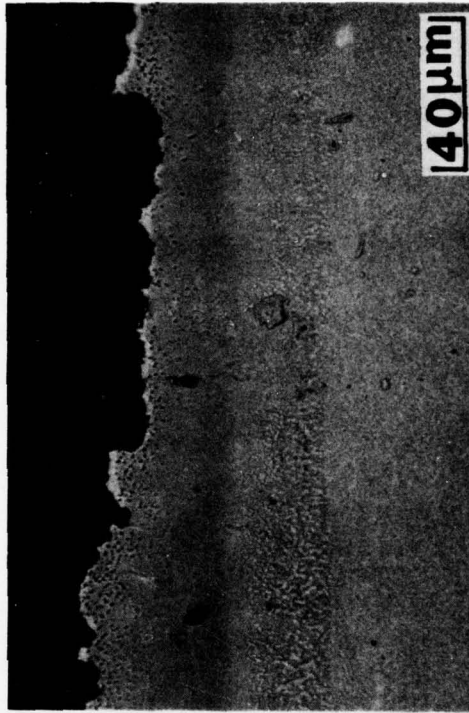
12a. Uncoated Mar-M509

12b. Uncoated IN 792

12c. Mar-M509/PWA 28 aluminide

12d. IN 792/PWA 273 aluminide

Figure 12. Uncoated and aluminized alloys tested concurrently with the CoCrAlY coating of Fig. 11 (i.e. 100 hours at 704C, $PSO_3 = 0.0007$ atm).

The aluminide coating on IN 792 was resistant to SO_3 effects at 704°C; although significant weight losses and surface degradation were observed, the coating was not penetrated even by 100 hours at 0.004 and 0.0007 atm (Figure 10, 12). Conversely, exposure to SO_3 at 899°C caused rapid sulfidation and penetration of the coating after only 20 hours (Figure 24).

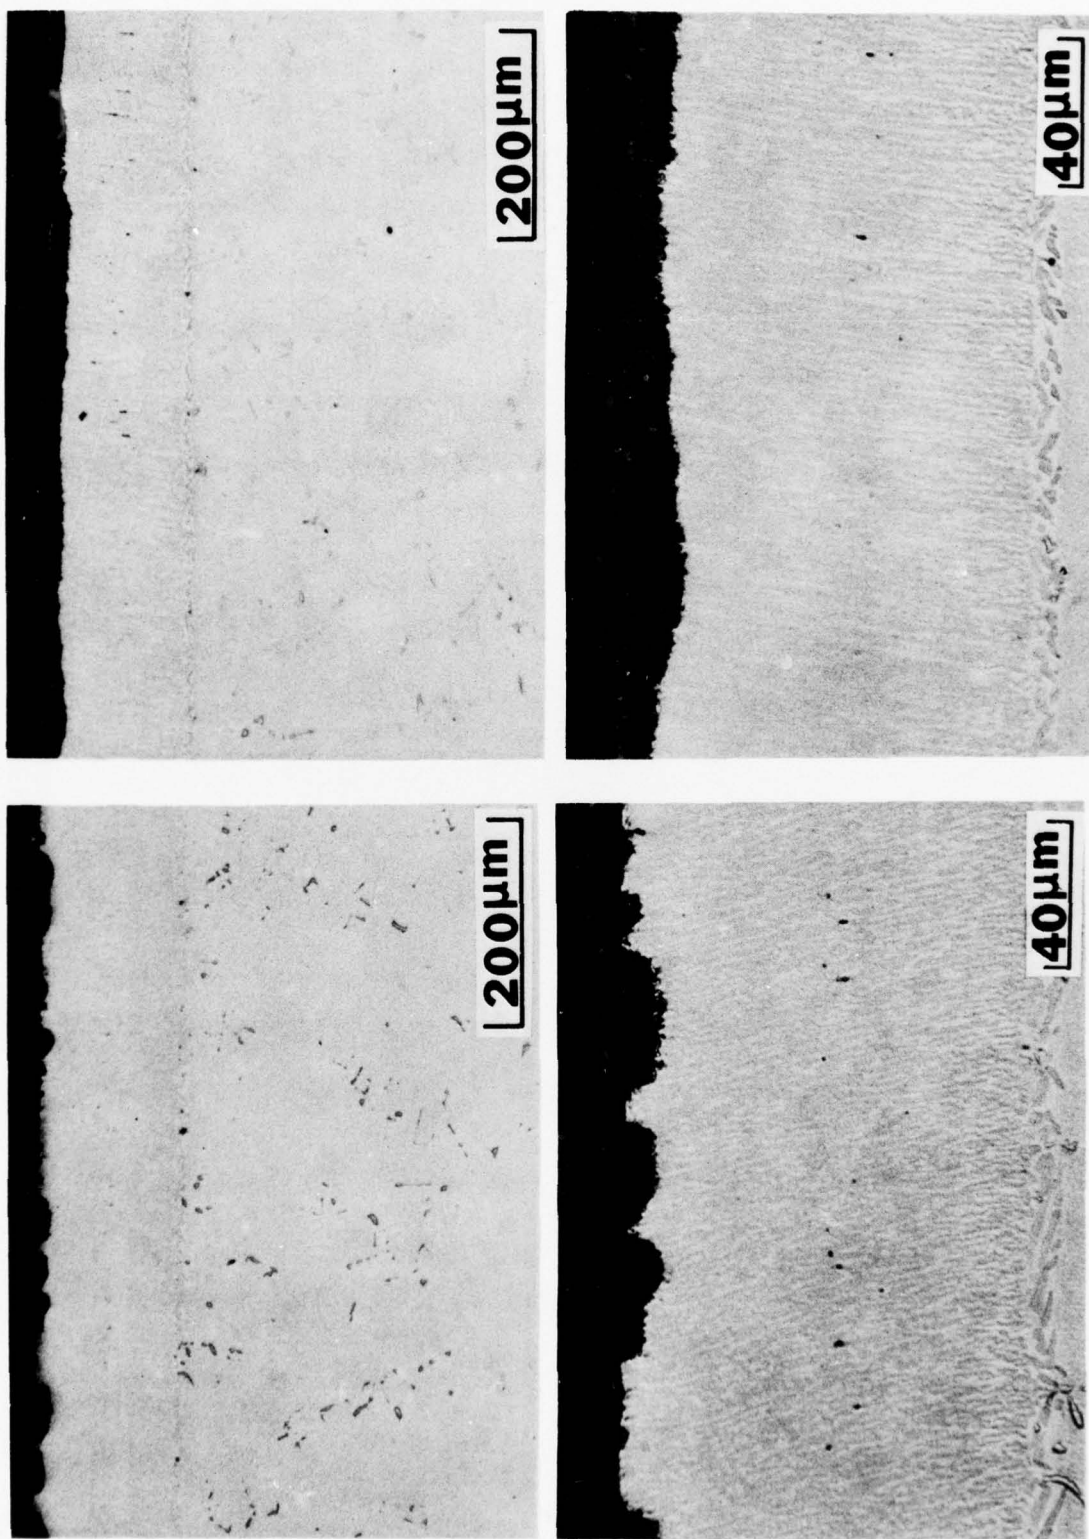
Figure 13. Typical microstructural degradation of PWA 68 CoCrAlY coating produced by cyclic hot corrosion testing for 100 hours at 704°C and $PSO_3 = 0.0001$ atm. Comparison with Figs. 9 and 11 shows effect of SO_3 pressure on depth of attack.

It is clear that SO_3 -induced hot corrosion of CoCrAlY is less severe at 899 than at 704°C. Although 100-hour exposure at 899°C and $p_{\text{SO}_3} = 0.0007$ atm produced substantial microstructural degradation in some areas (e.g. Figure 22), examination of the test coupons after 20 hours showed extensive corrosion at 704°C versus negligible attack at 899°C, and weight changes were much less at the higher temperature (Figure 28). At 0.0001 atm, the negligible 899°C attack indicated by surface condition (Figure 20c) and post-test metallography contrasts with the significant extent of corrosion shown in Figures 13 and 18.

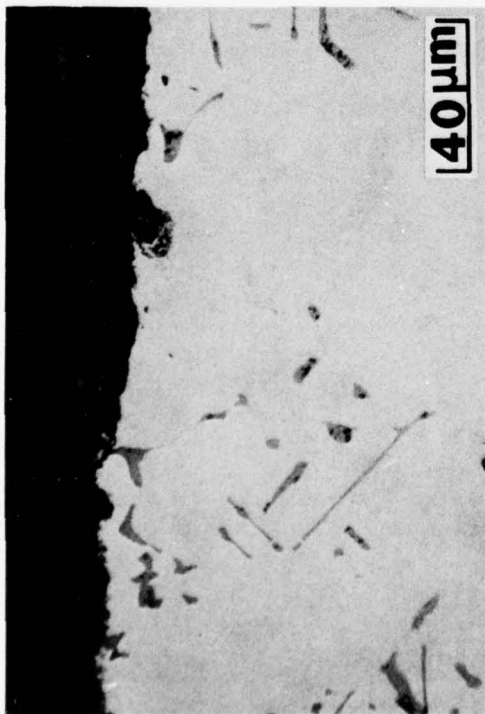
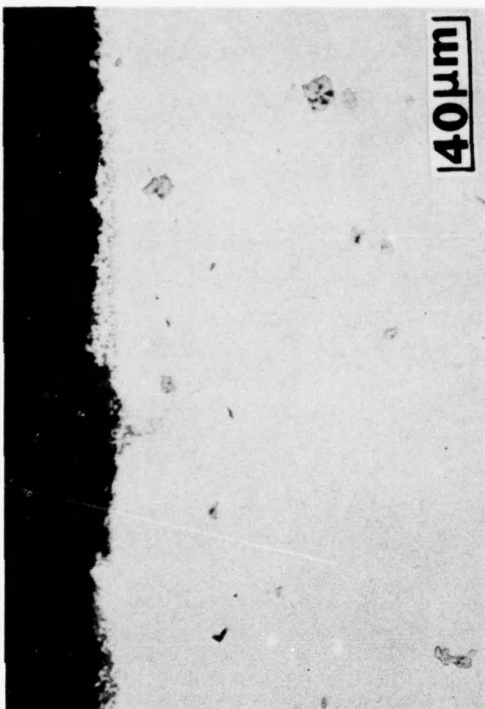
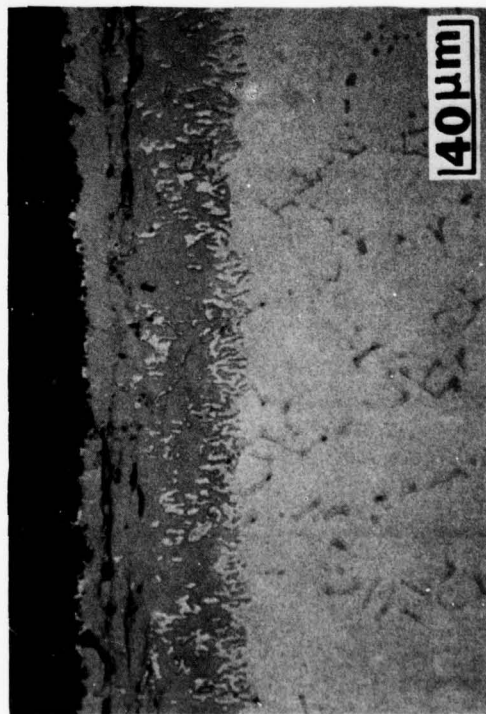
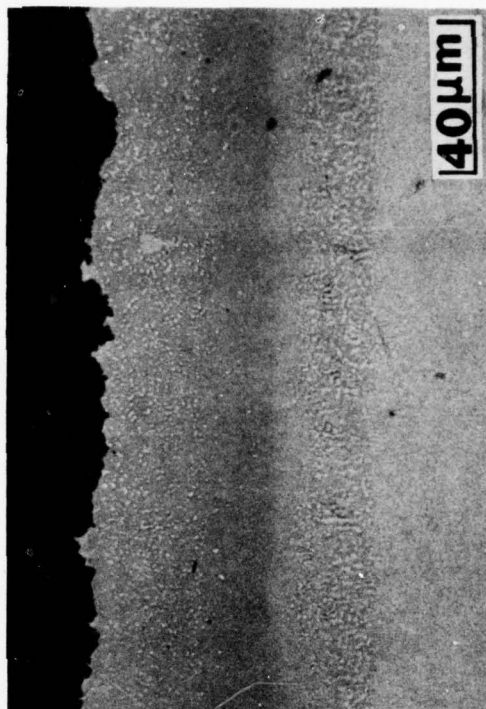
14a. Uncoated Mar-M509

14b. Uncoated IN 792

14c. Mar/M509/FWA 28 aluminide

14d. IN 792/FWA 273 aluminide

Figure 14. Uncoated and aluminized alloys tested concurrently with the CoCrAlY coating of Fig. 13 (i.e. 100 hours at 704C, $PSO_3 = 0.0001$ atm). Comparison with Figs. 10 and 12 shows effect of SO_3 pressure on microstructural degradation.

14. Uncoated and aluminized alloys tested concurrently with the CoCrAlY coating of Fig. 13.	54

Somewhat surprisingly in view of the performance of CoCrAlY and the uncoated Co-base Mar-M509, the aluminide coating on Mar-M509 was more severely attacked at 899 than at 704°C. Figure 29b shows a relatively large 899°C weight loss at 0.0007 atm; at the lower SO_3 pressure, Figure 26b versus Figure 14b again indicates greater microstructural degradation at 899°C, perhaps resulting from coating-substrate interdiffusion.
